TWR-17543, Vol. VII
ECS 1012

FLIGHT SET 360T004 (STS-30) FIELD JOINT
PROTECTION SYSTEM FINAL REPORT

20 September 1989

TWR-17543 Vol. VII
Flight Set 360T004 (STS-30)
Field Joint Protection System Final Report
Volume 7
Final Report

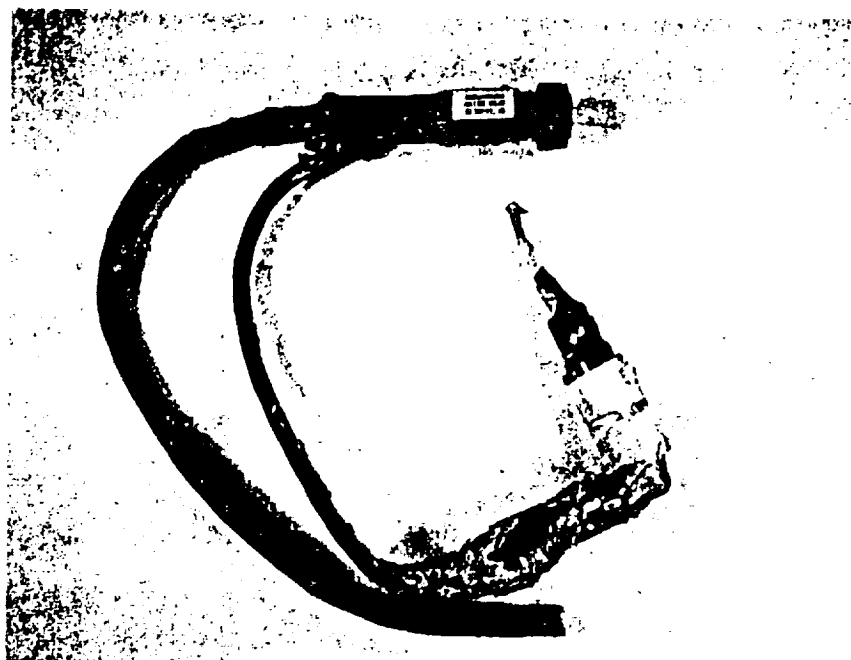
FIGURE 1
PHOTOGRAPH OF CABLE SEGMENT "AS RECEIVED".
MAGNIFICATION: 3X

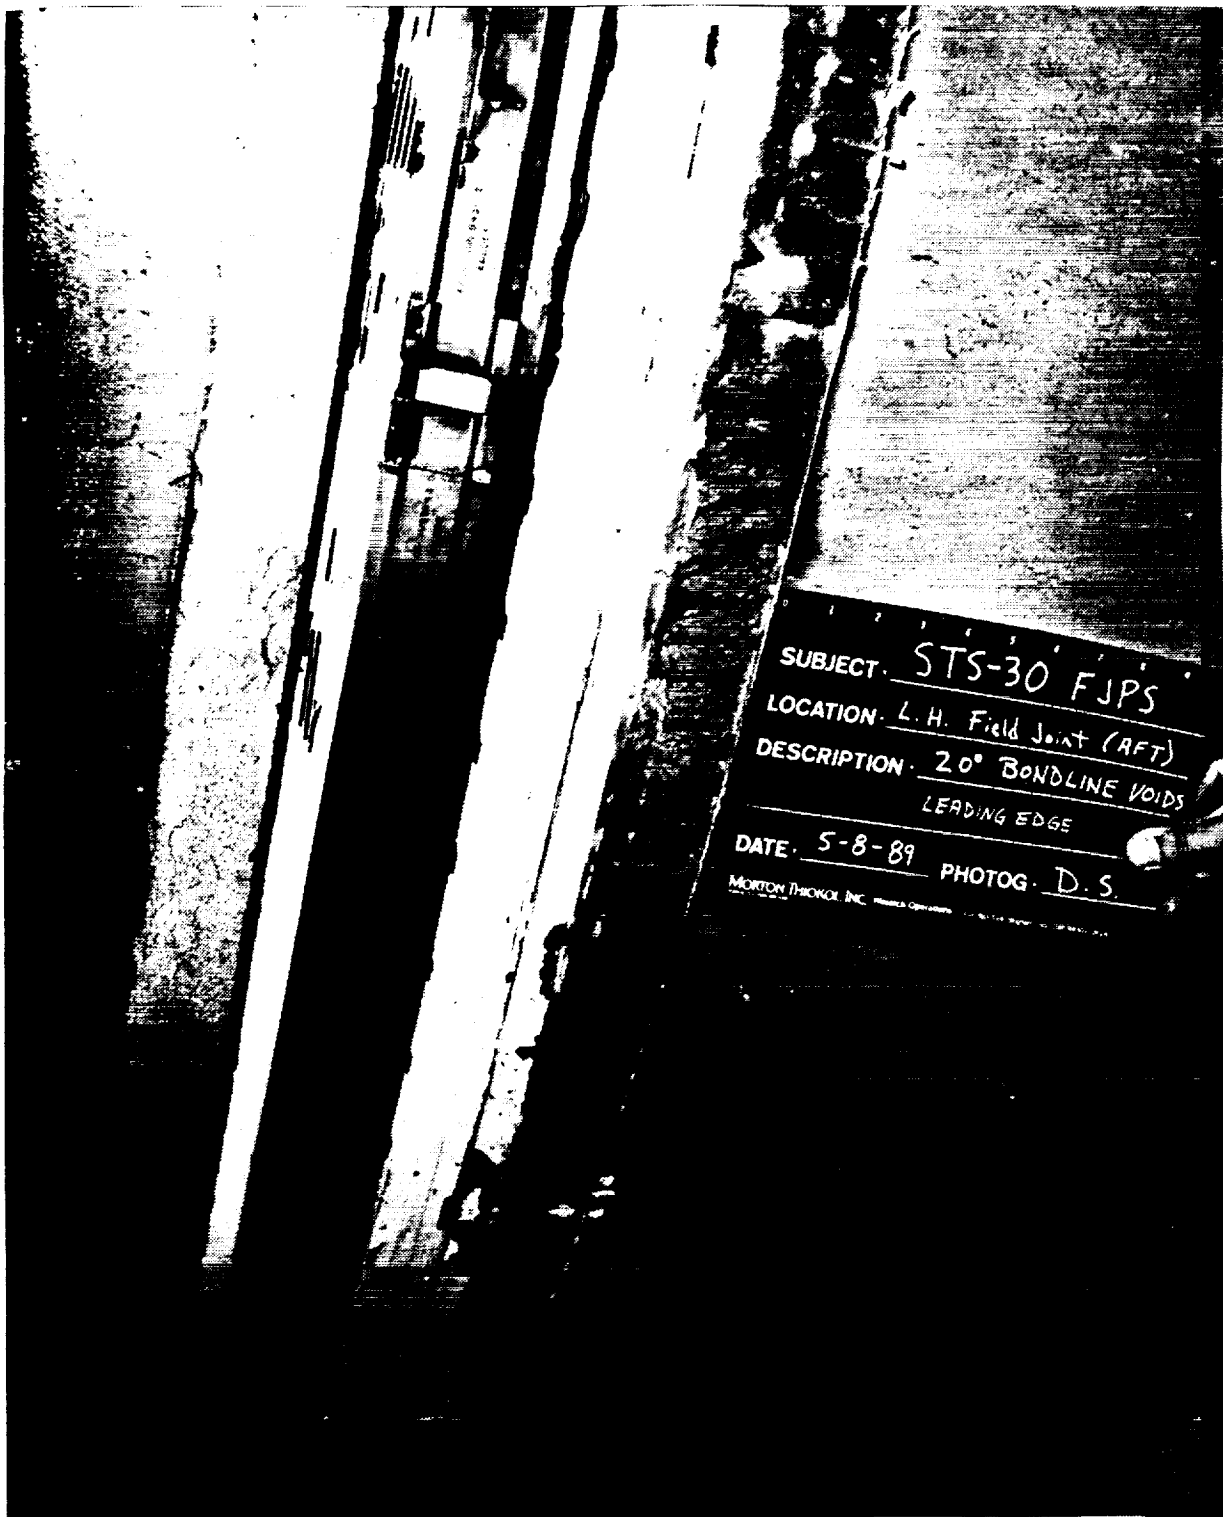
Figure 6 Debond under Leading Edge, Left Aft Field Joint

significant voids with areas of 15, 60* and 58* in.². The center field joint had seven significant voids with areas of 34*, 11, 22*, 5*, 7, 4 and 14* in.². A typical area (34 in.² intermittently) is shown in Figure 6. Tables 8 through 10 further document these voids.

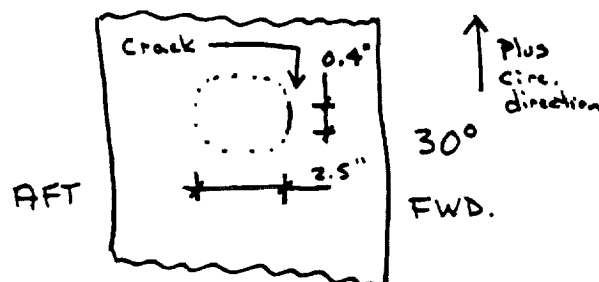
5) At the 30° trunion location a depression was found ~~on the trunion~~ (approximately 2.5 inches in diameter) and a crack (0.4 in. in circumference) was on the forward edge. When the depression was hand-pressed, water flowed out of the crack. See the figure below

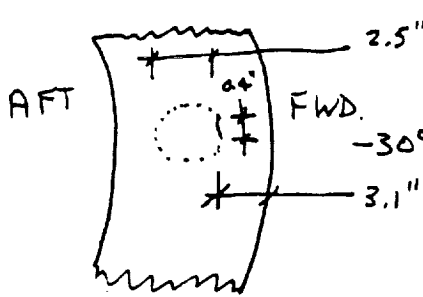
<p><u>FJPS on the motor</u></p> <ul style="list-style-type: none"> - A 2.5" diameter depression in the cork - A 0.4" circumferential crack through the cork and paint. The paint covered the ends of the cork crack. The cork crack appeared to run 1.3"

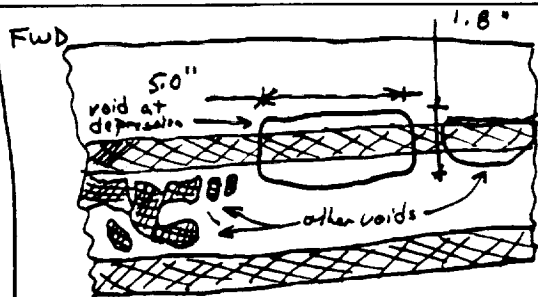
<p><u>Extruded Cork Off the Motor</u></p> <ul style="list-style-type: none"> - void at depression was 0.3 to 0.4 inch deep (radial)
---	--

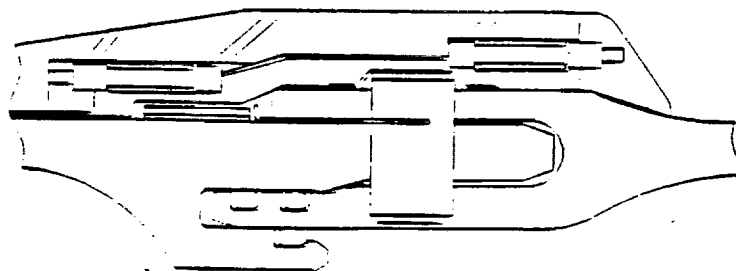
Deep Void (0.4 inch)

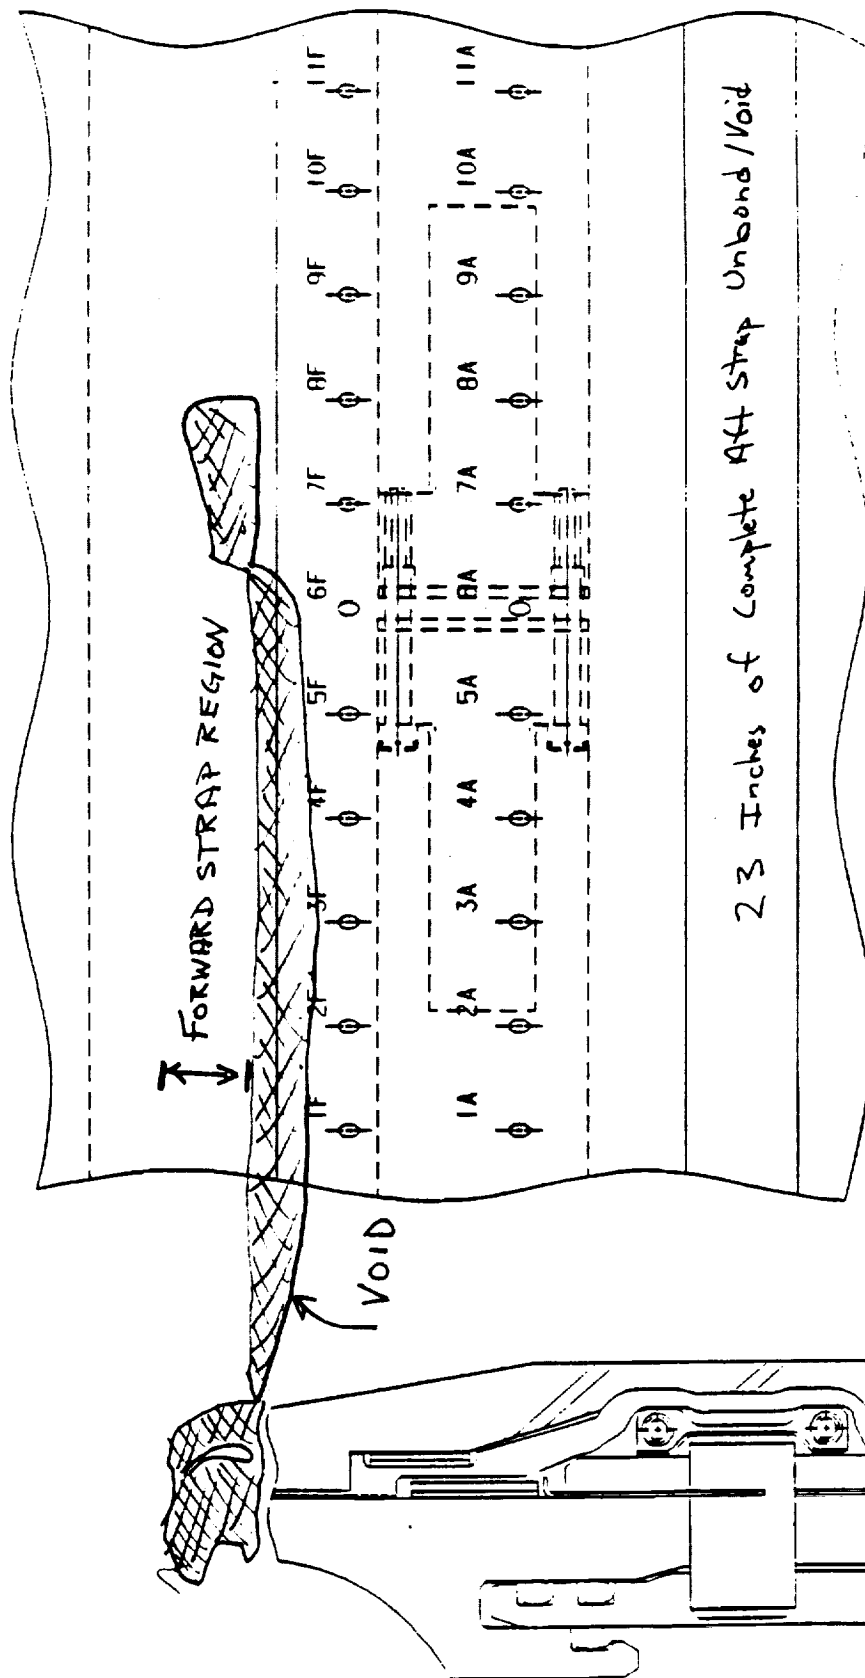
23 Inches of Complete Aft Strap Unbond/Void
